某超临界汽轮机主汽阀杆断裂原因分析

Failure Analysis on Main Steam Valve Stem of An Ultra-supercritical Turbine

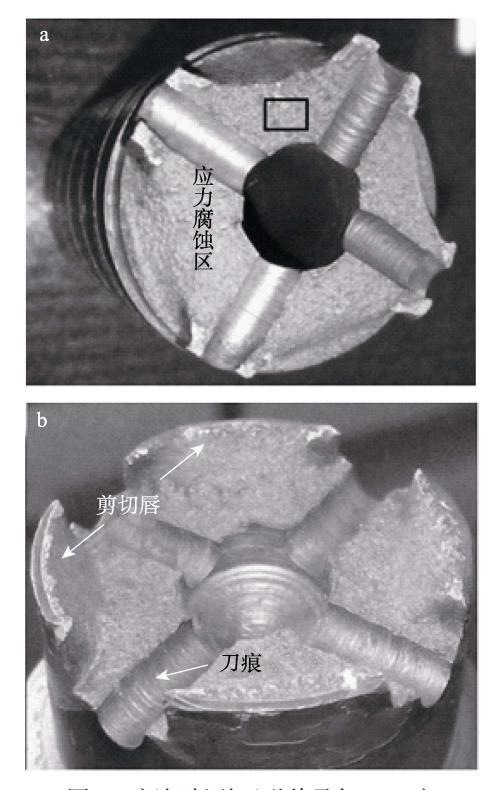
图 1 阀杆断裂面形貌及加工刀痕 Fig.1 Morphologies of the fracture surface and machining tool marks of the valve stem

如图 1a 所示,该阀杆断裂位置大致位于十字交 叉贯穿孔最大径水平截面处,断口表面粗糙,呈颗粒 状,整体呈脆性断裂特征。直径 5 mm 十字交叉贯穿 孔最大径水平截面处的有效承载面积(707 mm²)明 显小于未开孔处(957 mm²),因而,此处的应力水平 显著提高。加之该阀杆中心孔的加工刀痕非常明显 (如图 1b 所示),极易造成应力集中。此外,在图 1 的阀杆断裂面上有明显不同的 2 个区域,断面中部呈 暗灰色,占整个断口面积的绝大部分,存在明显的氧 化和腐蚀现象,说明主裂纹在缓慢扩展过程中不断被 氧化,腐蚀形成。阀杆外侧断口区域呈亮白色,新鲜, 为最终瞬断区,在阀杆边缘处形成剪切唇。采用 JSM-6490 型扫描电镜(SEM)观察阀杆断口(图 1a 上方框区域)形貌。可以看出,虽然阀杆内部形成的 微裂纹经受高温蒸汽的氧化作用,断口表面被氧化皮 覆盖,但仍分辨出冰糖状的断面特征(图 2),呈现 典型的应力腐蚀开裂特征^[4-5]。

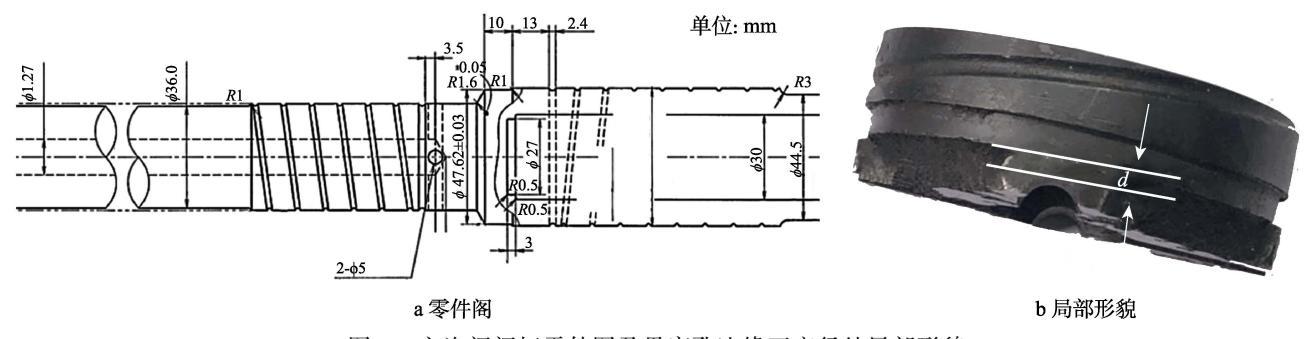
图 3 主汽阀阀杆零件图及贯穿孔边缘至变径处局部形貌 Fig.3 Part diagram of the valve stem (a) and (b) partial morphology showing the hole edge to the reducing diameter site

对照零件图(图 3a),测量该断裂阀杆 4 个十字 交叉贯穿孔边缘至变径处的距离 d,分别为 1.19、 1.26、1.61、1.69 mm,最大与最小值相差 0.5 mm。 该零件的设计要求 d 应为(1±0.1) mm,而尺寸公差最 高达 69%,不符合设计要求。此外,该阀杆零件 B 处有 *R*=0.8 mm 的圆弧过渡,而断裂阀杆该处则是直 角过渡(如图 2b 所示)。变径处本身存在应力突变, 采用直角过渡更加剧了应力集中,易在邻近的十字交 叉贯穿孔最大径水平截面上诱发裂纹,并失稳扩展, 最终导致阀杆的断裂。

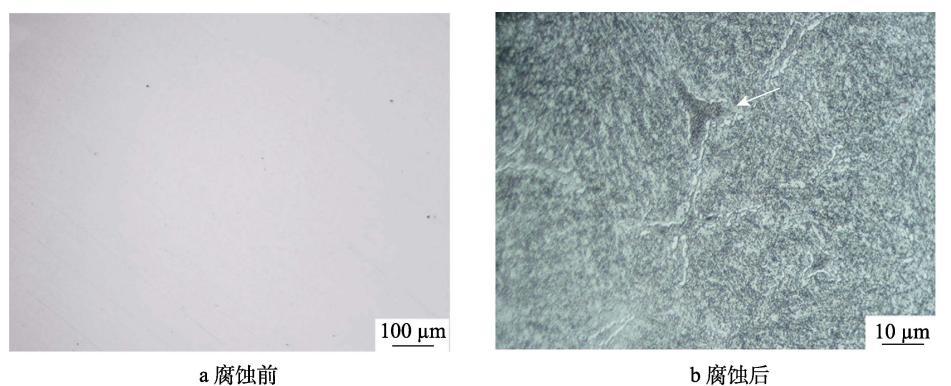
图 4 阀杆的金相照片 Fig.4 Optical cross-sectional images of the valve stem (a) before and (b) after etching

术导则》对该断裂阀杆进行金相检验。在断裂面附近 取样,研磨抛光,采用三氯化铁-硝酸的水溶液 (V(FeCl₃):V(HCl):V(H₂O)=1:2:4)腐蚀。将腐 蚀前后的试样分别置于 MR3000 型研究级倒置式金 相显微镜下观察。在该阀杆试样抛光面上,可见颗粒 状夹杂物的黑色斑点。根据 GB/T 10561—2005《钢 中非金属夹杂物含量的测定标准评级图显微检验方 法》,判定该 D 类夹杂物的等级为细 0.5 级(如图 4a 所示)。该阀杆显微组织为板条状的回火马氏体,阀 杆组织中有较为严重的组织偏析,呈网状分布,如图 4b 上箭头所示。

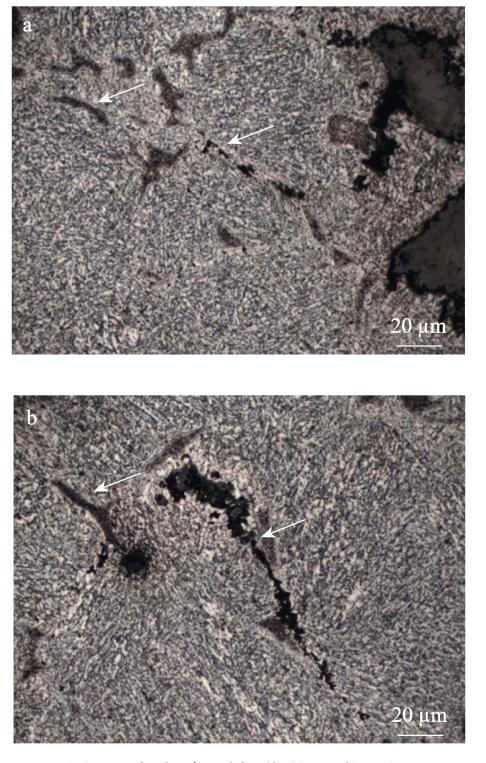
图 5 阀杆断裂部位的显微组织 Fig.5 Optical images showing fracture area microstructure of the valve stem

将该阀杆的断面打磨抛光,再经腐蚀后,观察其 显微组织形貌。如图 5 中箭头所示,在阀杆断裂面附 近区域内可见大量的微裂纹(二次裂纹),且二次裂 纹多沿偏析处扩展。这是因为网状偏析为力学性能的

弱化区域,为裂纹扩展的择优路径。二次裂纹前端尖锐,持续扩展,并互相合并连接。该二次裂纹表面已 发生氧化,说明在阀杆最终断裂前,高温高压蒸汽已 经通过主裂纹,进入阀杆内部的二次裂纹中,造成后 者的表面氧化。

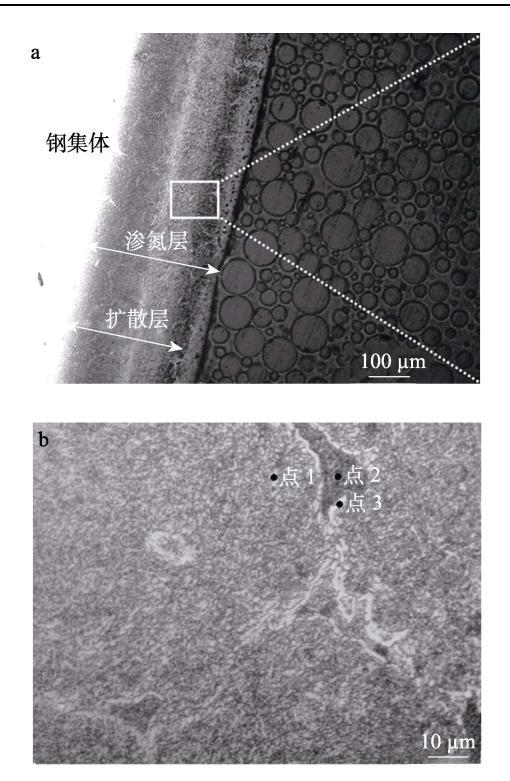
图 6 阀杆渗氮层截面形貌及图 a 局部放大像 Fig.6 Optical cross-sectional image of the nitrided layer of the valve stem (a) and (b) high-magnification image of the partial area in Fig.a

根据该阀杆加工工艺规范要求,除变径处外,阀 杆表面都进行渗氮处理,渗氮层深度要求为 250~ 350 µm, 以提高阀杆表面的硬度和耐磨性^[8-9]。采用 线切割截取含渗氮层的阀杆表面试样,研磨、抛光, 经 4%硝酸酒精溶液腐蚀后,观察其显微组织。如图 6a 所示, 渗氮层和 22Cr12NiMoWV 钢基体被区分开, 测得渗氮层厚度为 319 µm,符合渗氮层厚度要求。 渗氮层最外层组织呈灰白色,半连续状,厚度为20~ 30 µm,为 Fe2~3N 相和 Fe4N 相的混合组织^[10]。在其 内侧为回火马氏体组织的扩散层,厚度约为280 um, 占整个渗层组织的 80%左右。其中可见半连续状、 沿晶间分布的网状偏析,周围包围着白亮的第二相 (如图 6b 所示)。采用 Oxford INCA 型能谱分析仪 (EDS)测试图 6b 组织偏析区附近不同位置的成分, 偏析组织周围白亮的第二相(图 6b、7 中的点 3)较 渗氮层基体(图 6b、7 中的点 1)及偏析组织(图 6b、7 中的点 2) 含有更高的 N、Cr 元素含量,为 CrN^[11]。这种脆性氮化物沿偏析组织外围连续分布 的结构特征,加剧了阀杆组织不均匀性,导致其力 学性能降低。

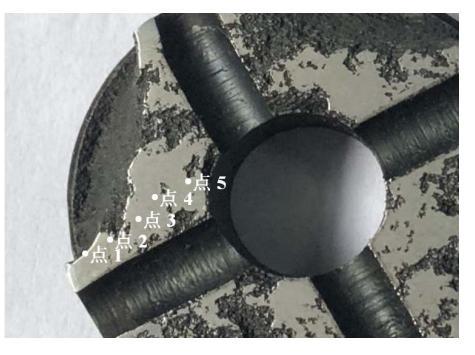
图 8 显微硬度测试点的位置 Fig.8 Microhardness test locations

在 1.96 N 载荷下,测得的渗氮阀杆试样从表面 直至基体的 1—5 点(图 8)处的显微硬度及经过换 算后的布氏硬度,见表 2。阀杆试样表面由于经过渗 氮处理,硬度高。试样中钢基体的硬度偏差较大,越 往阀杆中心处,硬度越低,表明该阀杆在渗氮处理前 的调质处理可能存在未淬透的工艺缺陷。
