# 岛礁环境对吊耳疲劳性能影响研究

**摘要:** **目的** 研究吊耳在岛礁环境下的腐蚀特征及其对疲劳性能的影响。**方法** 通过开展吊耳试验件的岛礁自然环境试验, 测试其不同在试验周期的疲劳性能, 分析断口形貌、元素含量变化, 研究腐蚀对吊耳抗疲劳性能的影响。**结果** 在1 a的岛礁自然环境试验中, 吊耳的腐蚀部位主要为表面镀层, 并且呈非均匀腐蚀特征。随着试验时间的延长, 吊耳平均疲劳断裂循环次数呈下降趋势, 疲劳断口的韧性断裂特征减弱, 并且氢含量有所增加。吊耳内部存在MnS夹杂物, 位于韧窝底部。**结论** 吊耳表面点蚀坑、内部MnS夹杂物对疲劳载荷作用下裂纹的萌生和生长起到促进作用, 降低了其抗疲劳性能, 应加强腐蚀防护和质量控制。

## Effect of Island-Reef Environment on Fatigue Performance of Lifting Lug

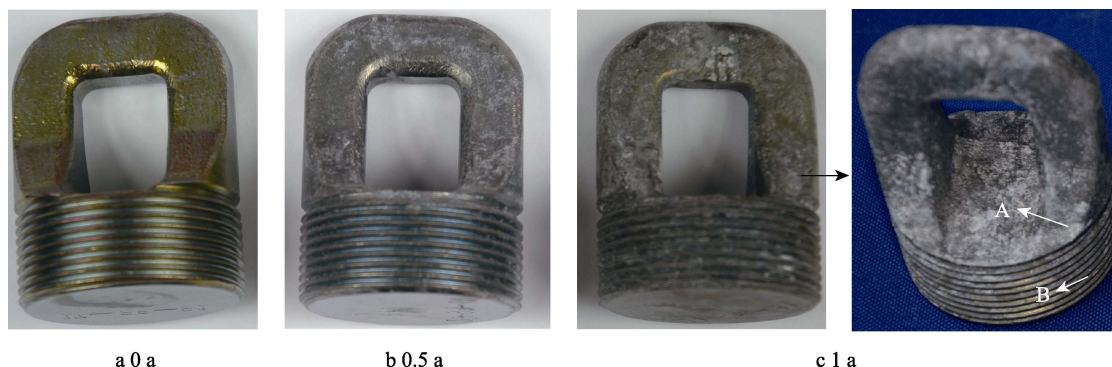
图 3 吊耳在永兴岛大气环境下暴露不同时间后的宏观形貌

Fig.3 Macroscopic morphologies of lifting lug after exposure on Yongxin Island for different periods

吊耳试验件在岛礁海洋大气环境下暴露不同时间后的宏观形貌如图 3 所示。可以看出, 试验前, 吊耳试验件表面较为平整, 且镀层较为光亮; 在岛礁海

洋大气环境暴露 0.5 a, 其表面金属光泽下降, 并且局部附有灰白色腐蚀产物; 暴露 1 a, 试验件表面的金属光泽进一步下降, 表面腐蚀面积和腐蚀产物均有所增加。对比试验件不同部位的腐蚀程度可知, 吊耳试验件上半部的耳环部位 (特别是图 3c 中箭头 A 所示的水平部位) 的腐蚀程度要高于其侧面部位 (如图 3c 中箭头 B 所示的螺纹部位)。

从吊耳试验件在岛礁大气环境暴露后的腐蚀特征和程度可知, 吊耳表面在海洋大气环境棚下暴露 0.5 a 即出现较明显的腐蚀, 并且随着时间延长而不断加剧。结合试验环境特征以及试验件的材料工艺, 分析认为, 试验环境属于岛礁环境, 该环境地区年均温度约 27 °C, 年均相对湿度约 82%, 是典型的热带海洋岛礁气候<sup>[15]</sup>。暴露于这种高温、高湿、高盐雾的海洋大气环境中的吊耳, 表面易形成薄液膜<sup>[17]</sup>。同时, 大气中腐蚀介质 (如氯离子) 不断沉积于吊耳表面, 并溶入液膜中, 而吊耳表面的锌镍层相对于吊耳基材为阳极性保护层, 会优先发生腐蚀, 并生成灰白色腐蚀产物。虽然试验件表面未出现明显的红棕色产物, 表明吊耳试验件基材尚未发生明显腐蚀, 但由于镀层厚度较薄, 随着试验时间的延长, 试验件表面镀层会不断腐蚀消耗, 使得其厚度减薄, 对基材的腐蚀防护作用将会下降。此外, 由于吊耳在自然环境试验过程中处于悬挂状态, 相对于吊耳侧面和底面部位, 大气中的水汽、污染物等能更多地沉积并附着于吊耳中的平面部位 (如图 3c 中箭头 A 所示部位), 使得这些部位的腐蚀相对其他部位更严重。

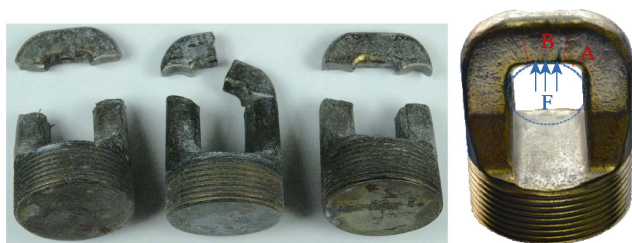
图6 吊耳试验件疲劳试验后的断裂宏观形貌

Fig.6 Fracture macroscopic morphology of lifting lug after fatigue test

暴露于海洋大气环境不同时间的吊耳, 其疲劳断裂特征和位置基本一致。在海洋大气环境试验 1 a, 吊耳的疲劳断裂宏观形貌如图 6 所示。可以看出, 吊耳断裂位置主要集中在耳环中间部位和内孔圆角处, 并且断裂端口较为平整。分析认为, 在疲劳试验过程中, 吊耳底部螺纹处固定, 耳环处通过圆柱状连接件连接, 会受到拉伸载荷, 使得耳环内孔圆角处 (A 所示部位) 和中间部位 (B 所示部位) 容易产生应力集中<sup>[11]</sup>, 成为薄弱部位而发生断裂。
