# 稠油热采井防砂筛管失效机理及完整性研究

**摘要:** **目的** 防止热采井筛管损坏, 延长热采井防砂有效期。 **方法** 基于有限元理论, 分别针对基管和外保护套, 开展热采井优质防砂筛管在不同热应力补偿器及其安放间隔条件下的完整性研究, 并开展室内实验, 探究筛管在腐蚀、冲蚀共同影响下的失效规律。 **结果** 目前现场使用的热应力补偿器设计基本满足防砂筛管基管的力学完整性需求, 但无法保证外保护套的力学完整性, 无法避免筛管的热应力损坏, 建议在热应力补偿器设计时应充分考虑外保护套的受力状态及变形情况。纯高流速流体冲刷对管材本体无破坏作用, 却对冲蚀-腐蚀环境中腐蚀产物膜具有冲刷破坏作用, 冲蚀-腐蚀迭加条件是筛管冲蚀损坏的主要因素。 **结论** 合理的热应力补偿器加放及筛管材质选择, 有利于提高筛管完整性, 延长防砂有效期。

## Failure Mechanism and Integrity of Sand Control Screen in Heavy Oil Thermal Production Well

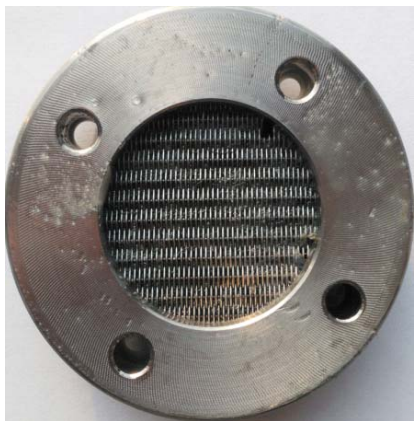
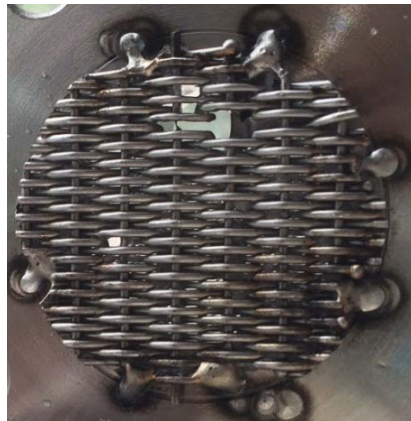
图 4 冲蚀后试样形貌  
Fig.4 Morphology of sample after erosion

试验压差为 1.0 MPa, 模拟石英砂粒径为 100~200  $\mu\text{m}$ , 筛网精度为 300  $\mu\text{m}$ , 单层筛网, 填砂量为 6 kg, 冲蚀时间为 5 h。冲蚀试验后如图 4 所示, 可清晰反映出筛网受冲蚀情况。在冲蚀环境下, 筛网

出现明显局部破坏, 冲蚀清理干净样片表面, 冲蚀磨损破坏区域特别明显。

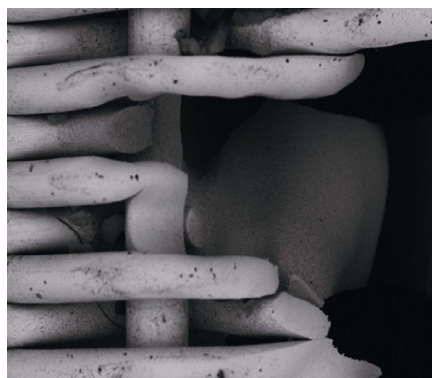
图 5 筛网冲蚀破坏点不同倍数下的 SEM 微观结构  
Fig.5 SEM microstructure at different times of erosion failure point of screen

采用 SEM 扫描电镜观察筛网冲蚀后微观形貌, 如图 5 所示。可知冲蚀条件下, 破坏区域主要集中在正对样片位置, 筛网局部损坏严重, 部分金属丝可见明显的磨蚀痕迹, 筛网存在砂粒堆积情况。
