# 井勇智,金国,李昕瑶,崔秀芳,温鑫,关亚杰

摘要:围绕海洋环境下航空发动机的服役特点,针对发动机叶片在海洋/近岸地区不同气候条件下的工作状况,对发动机冷端叶片在腐蚀-冲蚀联合作用下的失效机制进行了梳理总结。对海洋环境下服役的发动机叶 片防护涂层的相关研究进行了归纳,总结了不同叶片防护涂层的设计理念及其性能表现。对于航空发动机 叶片的防护涂层,目前主要是以一元或多元金属氮化物涂层,和金属相与陶瓷相的键合涂层为主,两类涂 层的设计目的在于通过控制涂层中的相含量来调控涂层的强韧比和耐磨耐蚀性。

# **Overview of Erosion Damage and Protection of Cold End Blades** of Aircraft Engine under Marine Conditions

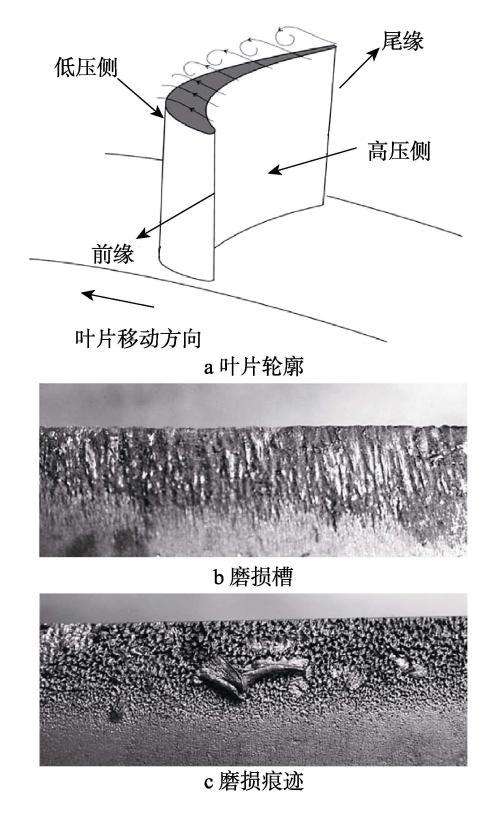
图 1 典型叶片轮廓、叶片尾缘的磨损槽和叶片前缘的球 形磨损痕迹<sup>[7]</sup>

Fig.1 (a) Typical blade profile, (b) trailing edge of the blade, shows parallel wear grooves in the same direction of the blade movement, (c) leading edge of the blade with features of globular wear marks<sup>[7]</sup>

军用飞机在海域起降及低空飞行过程中,发动机 会吸入大量盐气和含盐雾滴。在近岸与岛礁的起降, 还需考虑靠近地面时地表的大量砂尘被连带吸入发 动机内部的情况,这将对发动机各级叶片造成强烈的 冲刷腐蚀效应。与此同时,叶片在高速旋转的情况下, 经历固体颗粒的全方位冲蚀以及高频循环应力的作 用。冲蚀-腐蚀的联合作用,使叶片产生材料损失和 塑性变形,如图 1 所示。因此,在海洋/沿海服役环
